THE CHURCHYARD OF ST BOTOLPH WITHOUT BISHOPSGATE  
FOUNTAIN REPAIR  
BISHOPSGATE  
London EC2

An archaeological watching brief report

April 2009

Site code: SBT09  
National Grid Reference: 532717 182244

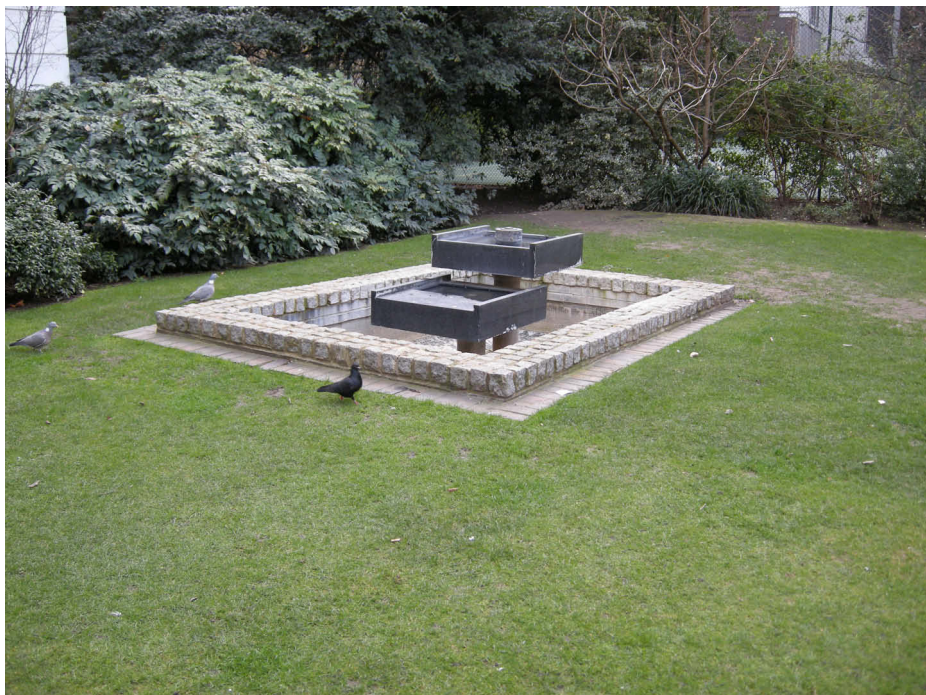
Fig 3 The fountain, looking south-west

The fountain located in the south part of the churchyard was subsided on its west side (Fig 3). A plan and sections based on the original construction drawings (City of London drawing no. 233-08-AR-E(0)1) show the foundations to be composed of concrete, fabric and hardcore, with a deep pump pit beneath the west end. An exploratory trench was excavated adjacent to it to determine the cause of the subsidence and potentially to remedy it.

The fountain is situated over the backfilled medieval City ditch. It is also constructed in graveyard soil which was probably disturbed a number of times during the use of the burial ground. This combination has resulted in the ground being soft and evidently the weight of the fountain, in particular the pumping machinery, has caused subsidence.

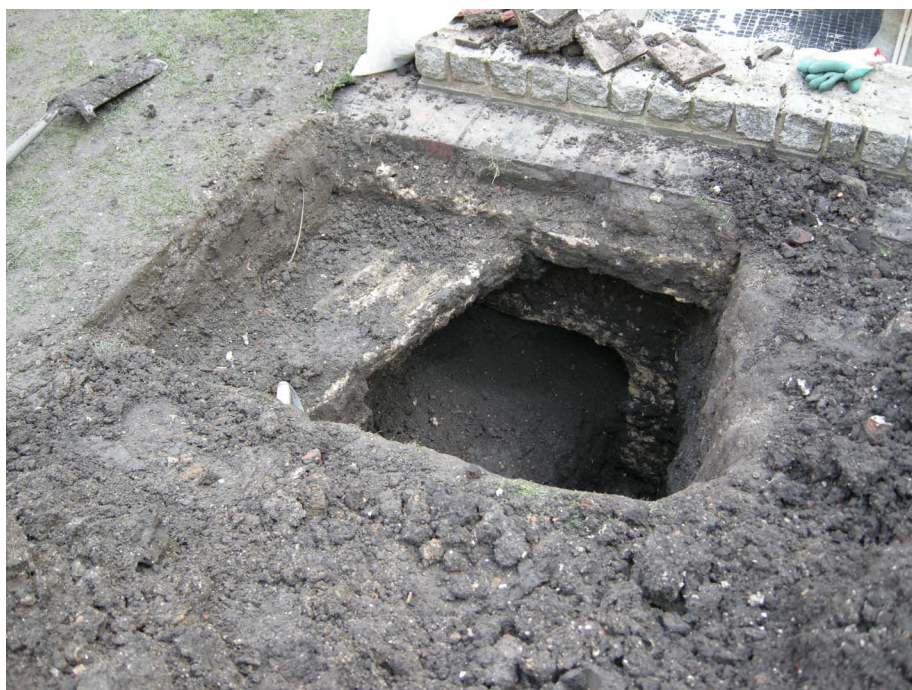
Fig 4 The trench after excavation, east to top of photograph

The resulting trench was 1.5m deep and showed that the concrete foundation to the main part of the fountain extended to 0.9m below ground level. However, the machinery which operates the fountain was housed in a block of concrete which was considerably deeper, extending down to 1.5m deep (Fig 4).

A small exploratory cut was dug beneath the shallow part of the foundation to determine whether it was deeper further to the west, or whether there was hardcore material beneath it, but this was found not to be the case.
