ST PAUL'S CATHEDRAL SOUTH CHURCHYARD  
London  
EC4

An archaeological watching brief report

Site Code: SCP04  
National Grid Reference: 532020 181110

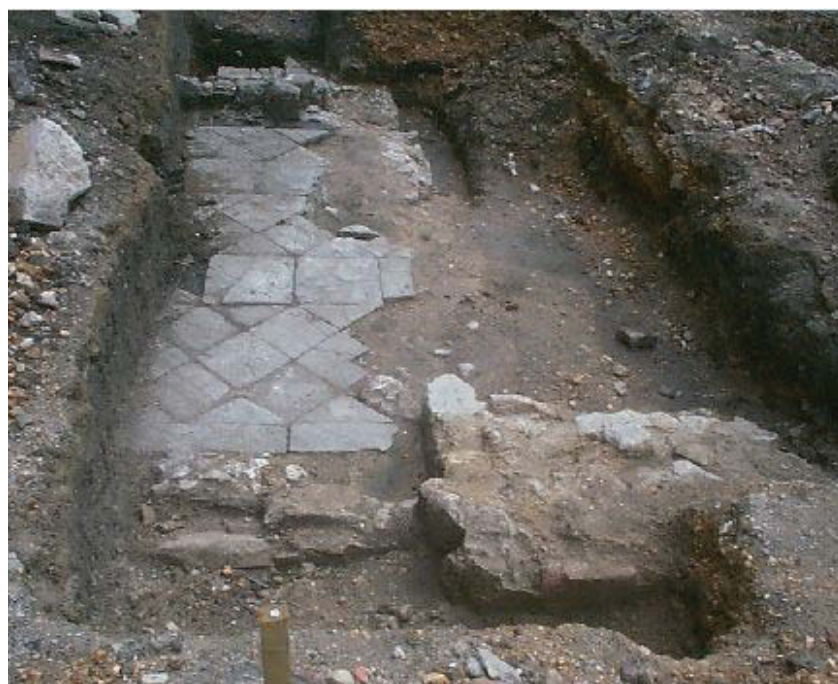
*Fig 4 Trench 9 looking east*

The exposed remains were the western external cloister wall [79], a section of the west range cloister walk floor [80], a much damaged portion of the internal western cloister wall [81] and its return to the south range, and a portion of the threshold to the west of the cloister [82].

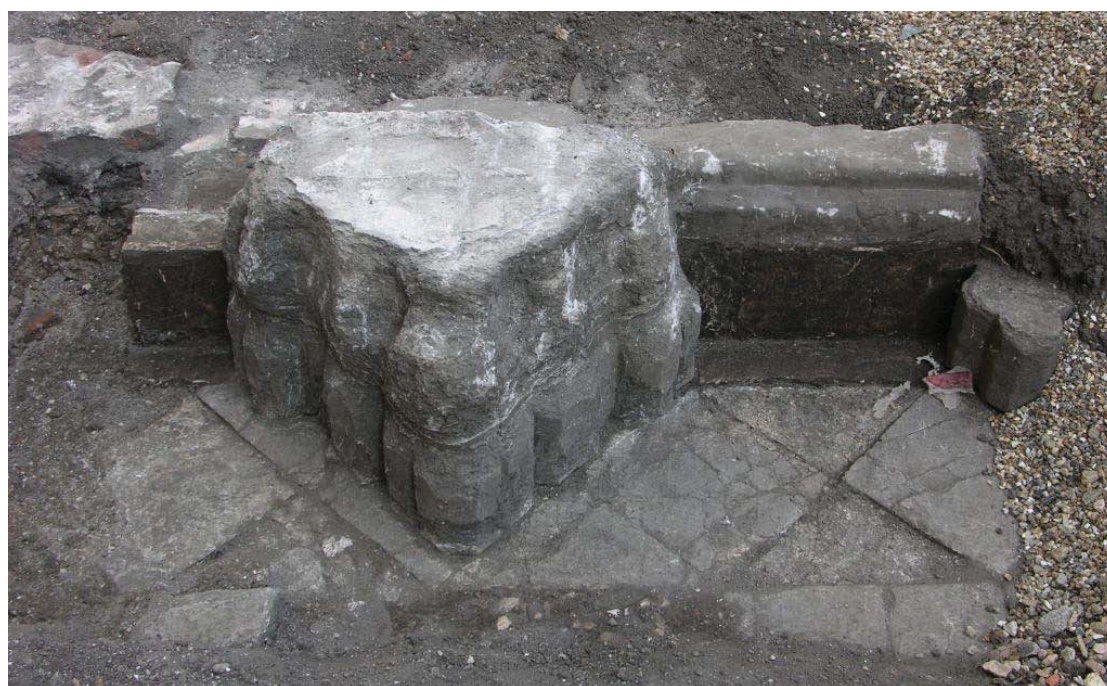
*Fig 6 Trench 10, north is to left, trench 9 backfill (pea shingle) to right*

The exposed remains were the internal western cloister wall [83], a portion of medieval floor adjacent to the wall [84] and some brickwork built inside the cloister [85].

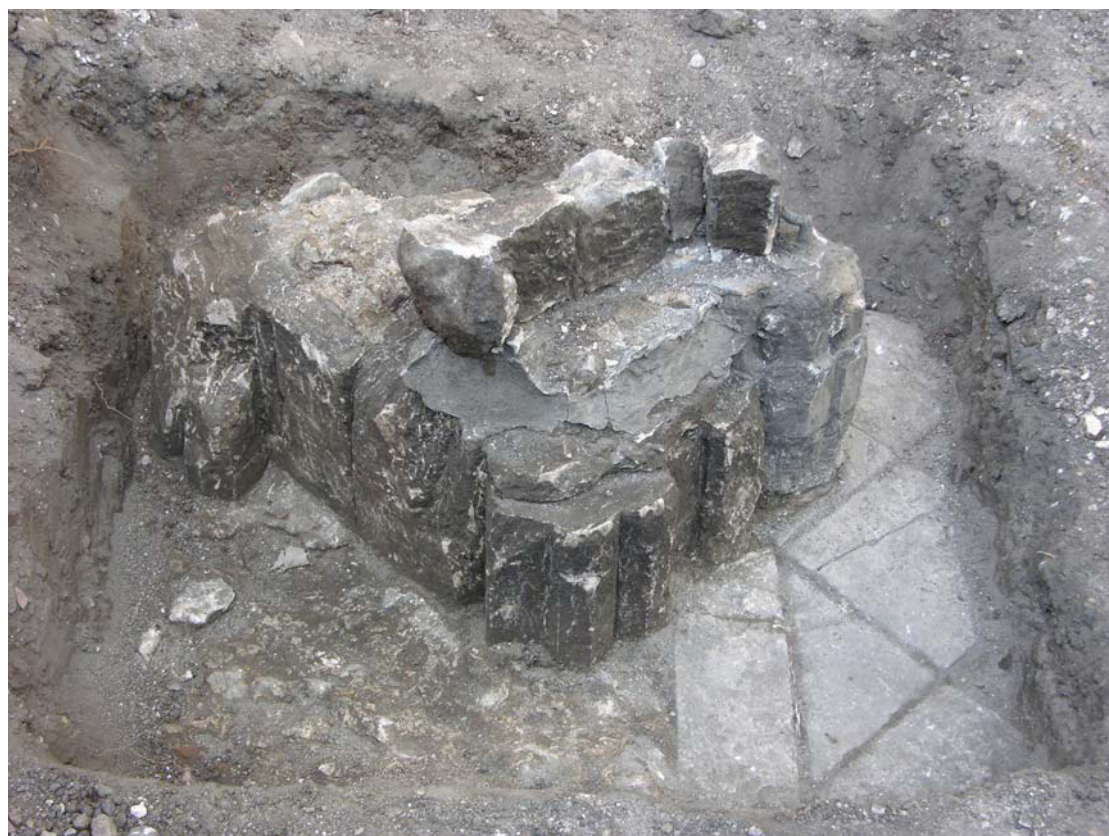
*Fig 8 Trench 11 looking north*

The exposed remains were the external western cloister wall [86], a portion of medieval floor adjacent to the wall [87] and the north side of the threshold [88].

The exposed section of wall was only 1.2m E-W and 800mm N-S. On the top of it was an attempted repair thought to date from the late 19th century. It took the form of heavily damaged wall construction blocks (sawn yellow limestone mortar) attached to the top of the remains by an iron tubular dowel in the pier base and Portland cement-based mortar. The over-all form was that of a projecting pier and door jamb

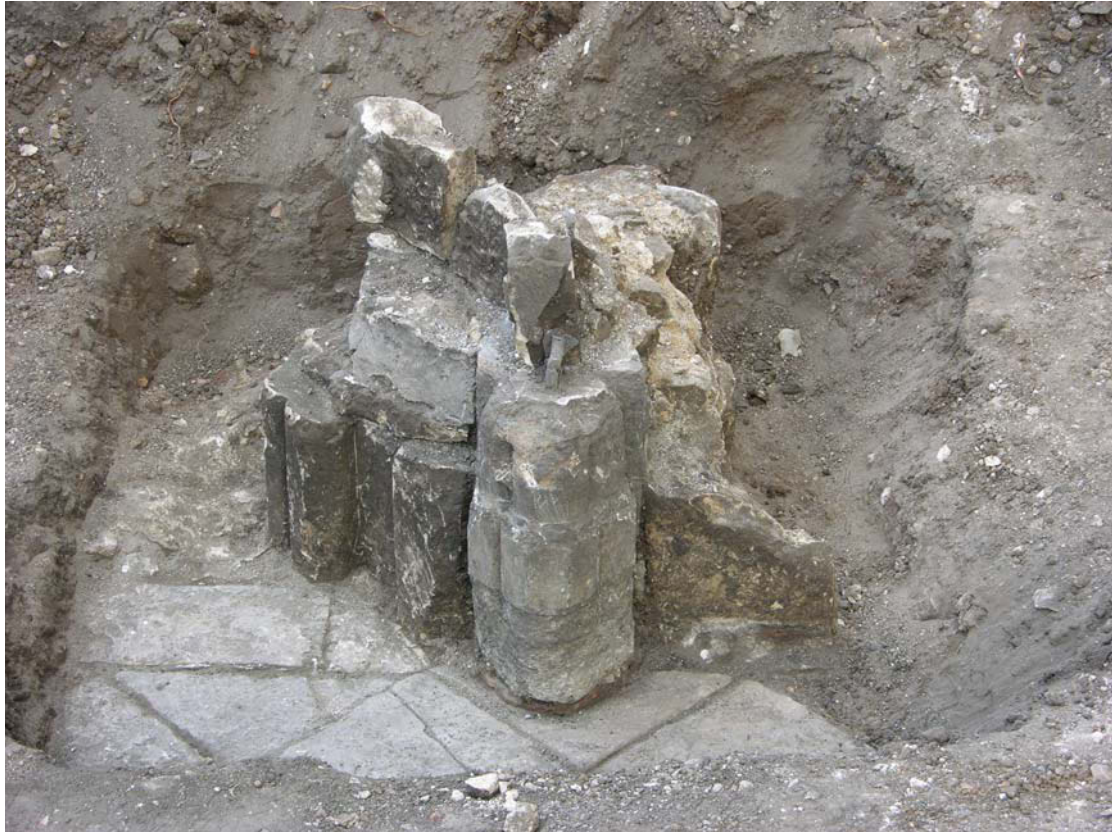
*Fig 9 Trench 11 looking west*

around the terminal of the cloister wall. A single facing block of sawn yellow limestone remained north of the pier. Again the pier base was an attached composite pier but perhaps as small as 300mm N-S x 250mm E-W (some of it was obscured by the later repair).

The form was little more than that of the trefoil-shaped shaft discussed above. However, it was more pointed and it should be compared with the carved limestone blocks adjacent to it. They formed the door jamb, comprised of several grey, non-oolitic, limestone encasing the terminal of the wall. The pier holding the vaulting would have merged with the decorated door jamb in a single ribbed effect. The limestone blocks took the form of a ribbed extension to the pier base, followed by a shallow triangular ribbed door jamb for the narrowest part of the threshold – of three ribs similar to but shallower than the trefoil-shaped shaft. This was followed to the west by two sawn square blocks set at an angle to the threshold, to form a widening opening. Outside of them was a damaged block with two projecting ribs, which may have had a 3rd, subsequently truncated. The core of the wall was poured yellow sandy lime mortar and rough-hewn ragstone blocks (in the main) <400mm diameter. As with trench 10, it had been truncated to the north.

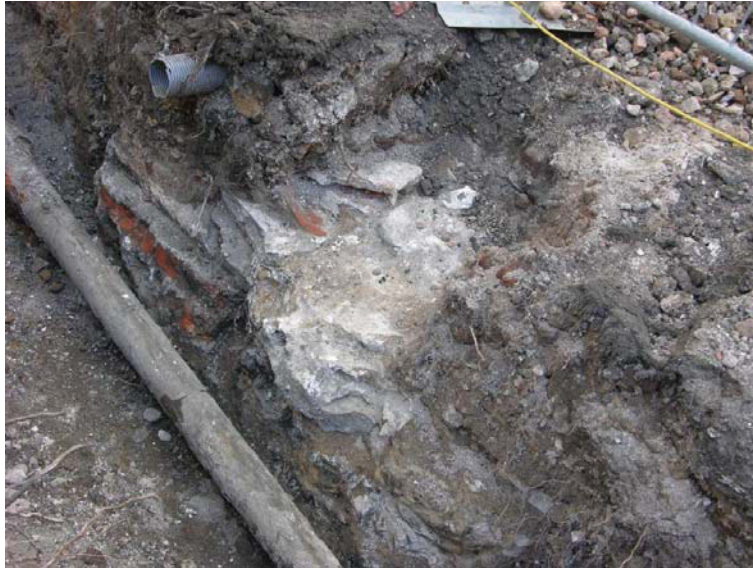
*Fig 10 Chalk foundation [91] and brick foundation [92], looking northeast*

Repair of a water pipe exposed the south edge of the southern range inner cloister wall foundation [29] (evaluation – trench 5). Medieval floor levels had been removed but the original pipe trench had also cut through the outer wall foundation [91] and inside it was a red-brick built foundation [92]. Whereas the drain trench had cut through remains, which were mainly observed in section, a small 0.6m square area of topsoil was removed from the junction of foundations [91] and [92] to observe them in plan.

Exposing the foundations in plan indicated that the brick foundations had been built alongside and over the top of the cloister foundations; following their alignment. The bright red, almost scarlet, colour – and the softness – is typical of bricks made of the local brickearth in the 17th century (c.f. brick wall [85] for atypical hard purply red bricks with coal dust additives).

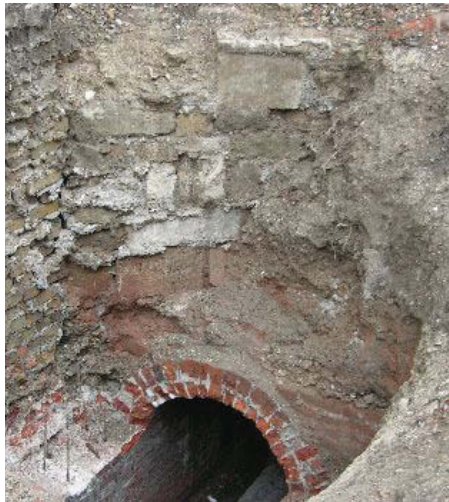
*Fig 12 Wren culvert [95] with foundation [94] above, looking northeast*

General ground reduction east of the cloister exposed a large, curving, bright red brick foundation cutting across the site [93]. Below it, exposed at the northern end where it was cut through by an existing inspection chamber, was a substantial stone foundation [94]. This was also exposed in the side of the new inspection chamber, 1.57m deep, underneath which the Wren culvert was exposed [95]. The culvert was broken into to form the new inspection chamber.

The construction cut for the culvert was wider than the exposure and it must have cut a wide trench around the cathedral. However, it is difficult to determine whether the stone foundation [94] was built after the culvert constructed – as represented in the context matrix below – or whether the culvert was tunnelled beneath it. Both stone and brick foundations are substantial features and if long-lasting structures above ground level would have been remarked upon in official documents. The fact that they are generally unremarked upon (John Schofield and Robin Wroe-Brown pers. comm.) tends to suggest that they were temporary enabling measures for Wren's – or Inigo Jones' – construction.

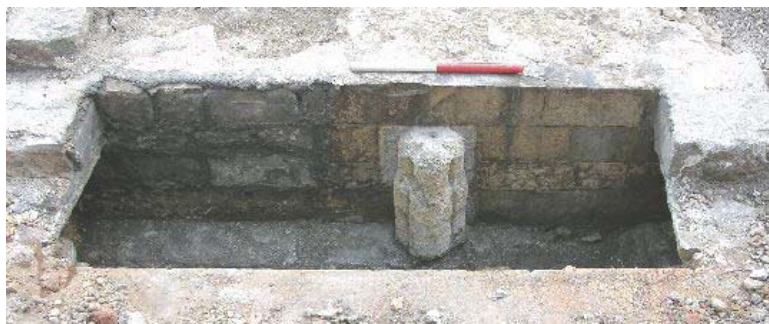
*Fig 14 Trench 15 looking south (half-metre scale)*

When the steps to the south gate were removed a void was exposed beneath them, constructed as a vault to preserve the medieval cloister. The south – external – wall [95] formed the south wall of the vault and the much damaged floor [97] its base. The south wall was repaired [98] to support the steps and a wall around the other three sides [99] with the steps forming the roof.

This was a previously unknown section of wall and is amongst the best surviving. The detail of the trefoil-shaped shaft indicates that above 15.6m OD the shaft stood proud of the wall and may well have reflected the tracery of the open arcade on the opposite wall. The truncation is thought to have occurred shortly before the creation of the steps, and the wall repair specifically for the purposed of making a chamber below the steps.

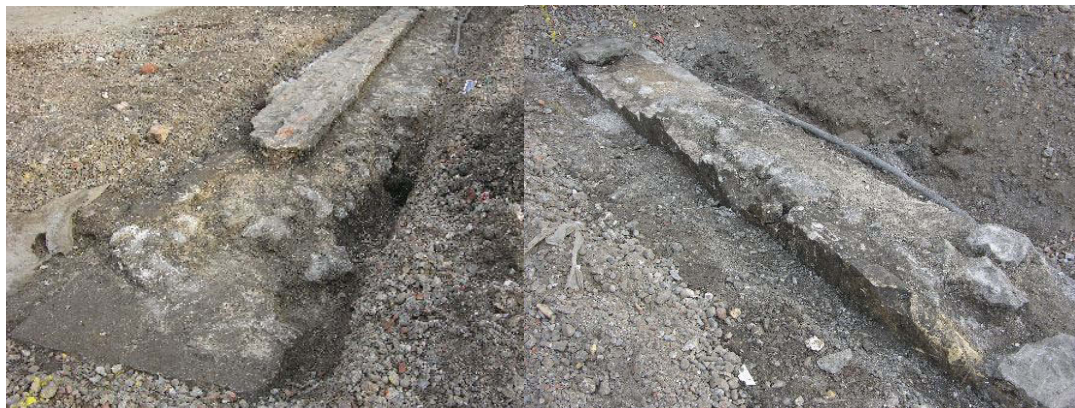
*Fig 17 Eastern outer cloister wall form the south (left, note the large corner blocks) and the highest surviving cloister remains (right)*

The eastern outer cloister wall [105] survived to a higher level than cloister walls elsewhere. The top of the wall was exposed but without clearance of material down to the medieval floor levels. Two sections of a protective masonry layer were exposed along the inner edge of the wall [103] and [104].

The outer cloister wall [105] survived to such a level that it protrudes up into the new-built wall (landscaped to represent the cloister). This required a redesign of the wall foundations. Part of this wall was recorded during the evaluation [52] (trench 4). Unlike that record of the overlying protective formation [103] is considered to be cemented with a lime mortar, though of a particularly hard nature – it being somewhat of a modern myth that lime mortars are perforce soft, rather they cure slowly. The identification as a lime mortar was due to the presence of white lumps within it. However, experiments were underway in the late 19th-century of composite mortars using both lime and Portland cement, particularly as this hardens more quickly. Earlier alternatives for a quicksetting mortar were adding calcinic clay (to yield carbon dioxide to the lime). Either clay or Portland cement may have darkened the matrix to grey. The angle of protective masonry [104] indicated it consolidated an end of cloister wall [105] that had been cut through and was consequently more at risk of having stones broken away. The most likely time that this work occurred was shortly after the 1870s exposure of the cloister.
